WASHINGTON FORESTRY CONSULTANTS, INC.

August 20, 2008

RE: Tree Evaluation – 3 Trees

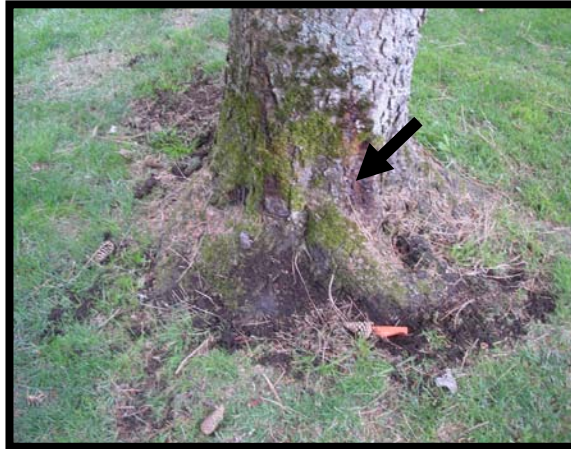
Examination of the root collar found pitch saturation (see Photo A below) on the lower 24 inches of the stem and exposed roots. Tissue samples in the northerly quadrant of the tree found mycelium of Armillaria root disease just under the bark. This white latex like mycelial mat was well developed. I did not excise enough bark to locate the rhizomorph, which would provide a positive identification.

In summary, it is my opinion that this tree is infected with a strain of Armillaria root disease. The tree will continue to show signs of stress and decline over time. This will appear as yellowing and thinning of foliage with minor, followed by major twig dieback. Eventually, the tree will die. This is a short-term tree, meaning I do not expect the tree to survive more than 15 more years. A tree killed by Armillaria root disease normally dies standing. Therefore, there is no cultural care prescribed beyond protection during the interim. There is no treatment for this disease. When the tree shows stress and decline to a point where it

Photo A. View of pitch saturation of the lower stem, a characteristic of Armillaria root disease (WFCI 7/31/08).

becomes unsightly, then remove the tree. New trees planted in this area will tolerate the disease as long as they are maintained in a healthy condition.

- 1) Monitor tree #1, the western hemlock. It will continue to decline overtime due to the infection with Armillaria root disease. Remove the tree when it become unsightly due to yellowing and needle loss.

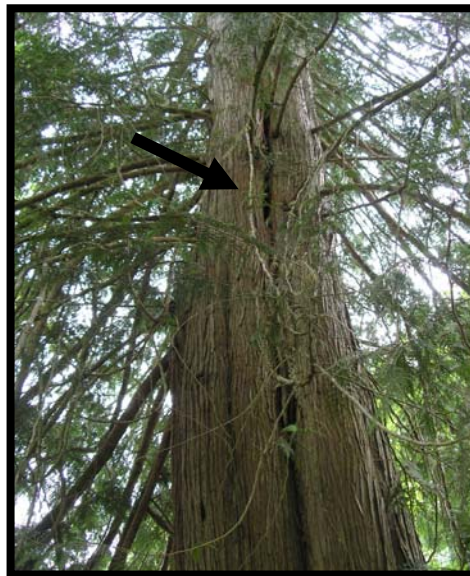
Photo B. View of cracked stem below split at 24 feet. The stem is hollow inside of the crack which extends to the ground line (WFCI 7/31/08).

The stem of this tree splits into two stems at approximately 24 ft. above the groundline (see above Photo B), and one of the stems splits again higher up, wrapping around the main stem. The north stem splits again at a height of approximately 55 feet. There is a crack in the stem starting at the first split. The crack extends from the split at 24 ft., down the stem to the ground. The opposite side of the tree also is cracked to a height of 8 ft. above the ground. The stems have visibly separated and the hollow is easily viewed inside of the stems.

Examination of the lower stem found the tree to be severely hollow. I did not core the tree; however sounding indicated the sound shell thickness is approaching the minimum (7 inches) necessary to support the tree, and is below the minimum for a portion of the stem¹.

The roots show evidence of decay, likely caused by damage during construction of the adjacent street.

In summary, this tree is in extremely poor condition with multiple structural defects, any one of which could fail. They include 1) root damage and root decay, 2) hollow lower stem that is cracked on two sides, to the ground on one side and to a height of 8 ft. on the other, 3) 3 splits in the stems all forming tight-V crotches which are highly susceptible to failure in western red cedar, and 4) a long, full crown that maximizes the weight and wind pressure on these structural defects.

The tree cannot be cabled and braced. There is not adequate sound wood to anchor a tree support system. Crown thinning would lighten and reduce wind pressure on the weak stem structure; however I do not believe this will reduce the tree risk significantly. We cannot move the targets; they are all fixed and high value. The parts of the tree that we expect to fail are all large.

Therefore, it is my professional opinion that this tree should 1) be removed and replaced with a new tree, or 2) reduced in size to create a wildlife snag by removal of the stem above 24 ft. and all foliage. This work should be done immediately to mitigate the high risk that this tree presents to surrounding targets.

- 2) This large western red cedar (tree #2) has multiple, severe structural defects in the form of a hollow stem, cracked stems, and tight-V crotches. The heavy, full crown is placing severe stress on these unstable stems. This tree is a very high risk to fail, is hazardous and should be removed immediately, or the risk should be mitigated by creation of a wildlife snag as recommended.

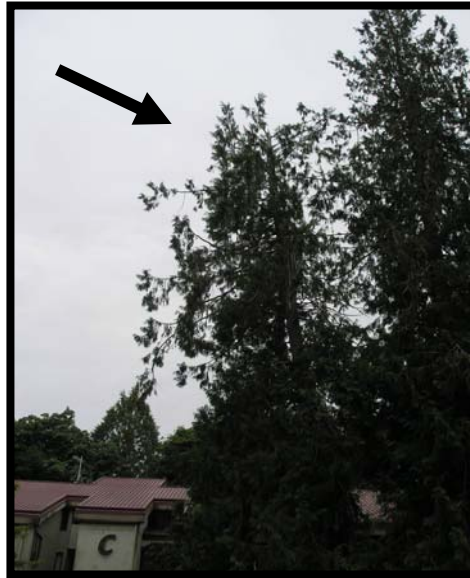
The tree recently has lost its top and has a heavy lean to the south, into the prevailing winds and winter storms.

Photo C. View of subject tree.

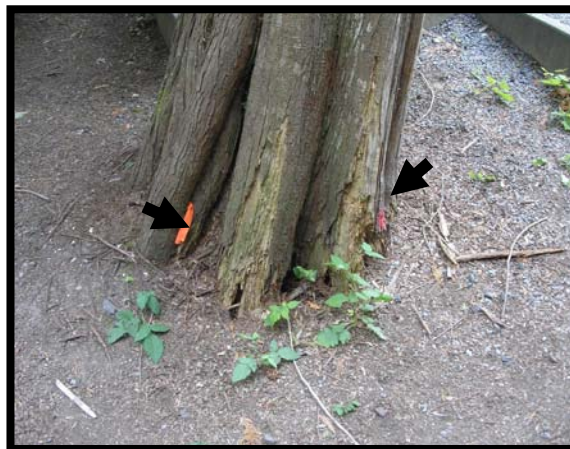
There is significant internal decay in this tree with severe decay at the groundline, indicating that some roots are decayed. This is likely the cause of the heavy lean, which is not natural for red cedar. Forty-nine percent of the stem circumference is rotted (see Photo D) at the ground line (root collar). The foliage of the tree indicates severe stress. It is slightly off-color and the foliage is thinning.

Photo D. View of decay at ground line – between arrows. Nearly 50% of root collar is decayed (WFCI 7/31/08).

In summary, it is my opinion that this tree is in decline, has severe internal decay in the stem and at the groundline, a heavy lean and is a high risk to fail. There are permanent, high frequency and high value targets surrounding this tree. There are no cultural treatments that will improve the safety of this tree. This tree is a very high risk tree and should be removed immediately.

- 3) This western red cedar tree (#3) has lost its top and is in decline. It leans heavily and has severe decay in nearly 50% of the root collar. This tree is a very high risk to fail, has targets all around it, and hazardous. It should be removed immediately. It cannot be made into a wildlife snag due to the lean and decay at the root collar, and surrounding targets.
