Snyder Cove Point Bulkhead Removal

## Feasibility Study Report

South Puget Sound Salmon Enhancement  
Group

November 2021

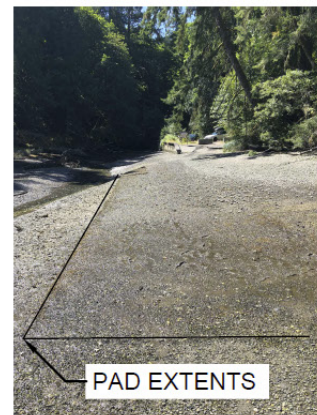
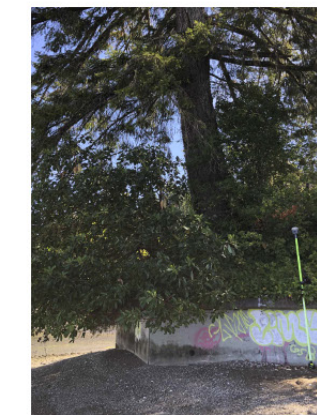
**Figure 1: Project Site Map**

The project site is located along the northern shoreline at TESC and spans two parcels (#12806410000). The limits of work for the restoration project include approximately 0.75-acres of upland area and 500 linear feet of shoreline (220 feet of which are armored) along Eld Inlet and Snyder Cove. The project shoreline extends from the lower parking area to the west around the point and to the eastern staircase (Figure 1).

The site is used primarily for recreation and public access to the beach for TESC students, staff, and faculty. Beach access is provided at three locations within the project area: a ramp from the lower parking area and an eastern and western staircase down to the beach from the upper parking lot. The site is armored with a concrete bulkhead wall that spans the shoreline between the two access staircases. The crest of the wall is approximately 18 to 18.5 feet NAVD88 and is currently about 3 to 5 feet in height above the adjacent beach. The elevation of the beach at the toe of the concrete bulkhead varies but is generally between 12 and 14 feet NAVD88. The wall appears to be in good condition with no visible damage or areas of spalling. The exact year that the bulkhead was constructed is unknown but was likely constructed in 1990 or 1991 (CGS, 2009). An older rubble

mound bulkhead was constructed in the 1980's to protect a large conifer tree on the western end of the point. It is likely that this older bulkhead is still located behind the existing concrete bulkhead (CGS, 2009). The eastern staircase does not appear to be connected to the bulkhead and is in good condition. The western staircase is in poor condition and is connected structurally to the concrete bulkhead.

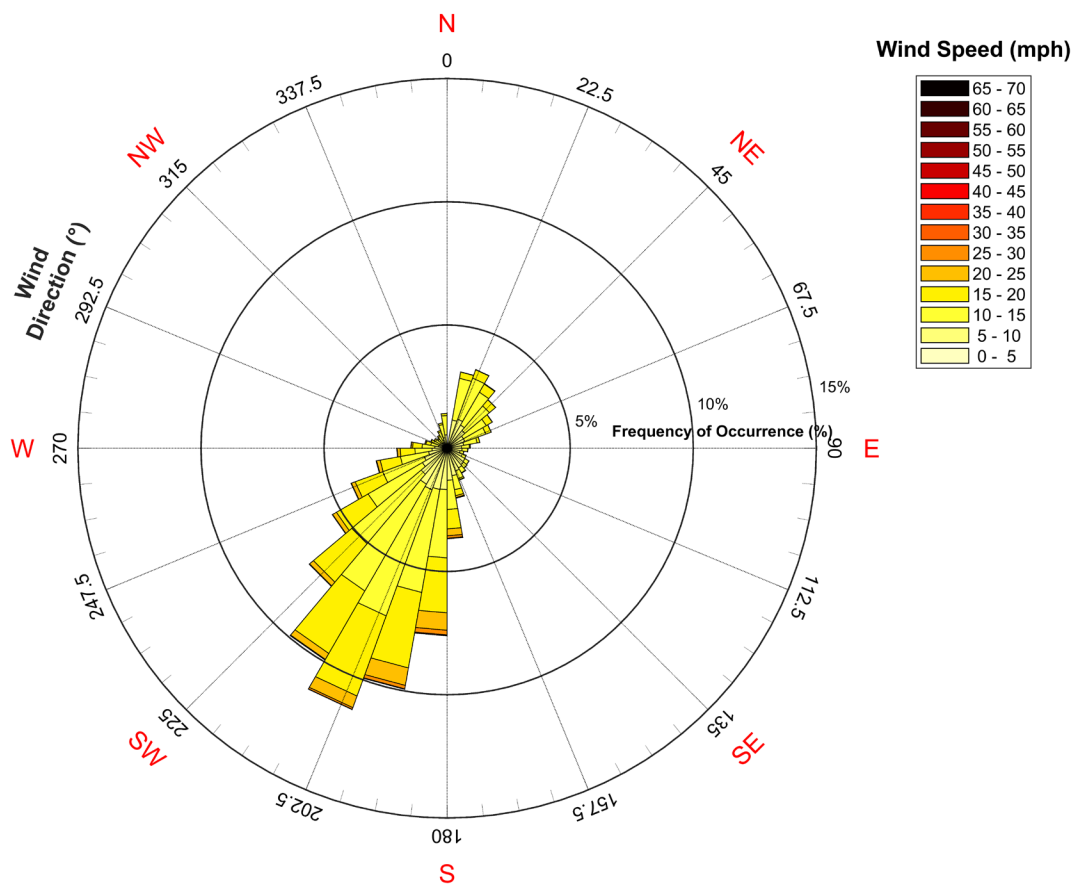
Figure 3. Wind rose for the hourly wind record at the Olympia Airport station from 1970 to 2021.

The characterization of the wave climate was performed using hourly wind records from the selected station (OAS), located 9 miles to the southeast. A wind rose for the station record from 1970 to 2021 (Figure 3) shows the bimodal wind distribution (two dominant directions; southwesterly and northeasterly) which aligns primarily with the local topography. The most frequently occurring and strongest winds are from the south and southwest (170° to 250°) consistent with the broader regional wind patterns in western Washington. The prevailing wind direction in western Washington is from the south and southwest in the winter and west and northwest during the summer (Overland and Walter 1983). The strongest winds are typically from the south during winter storm events.

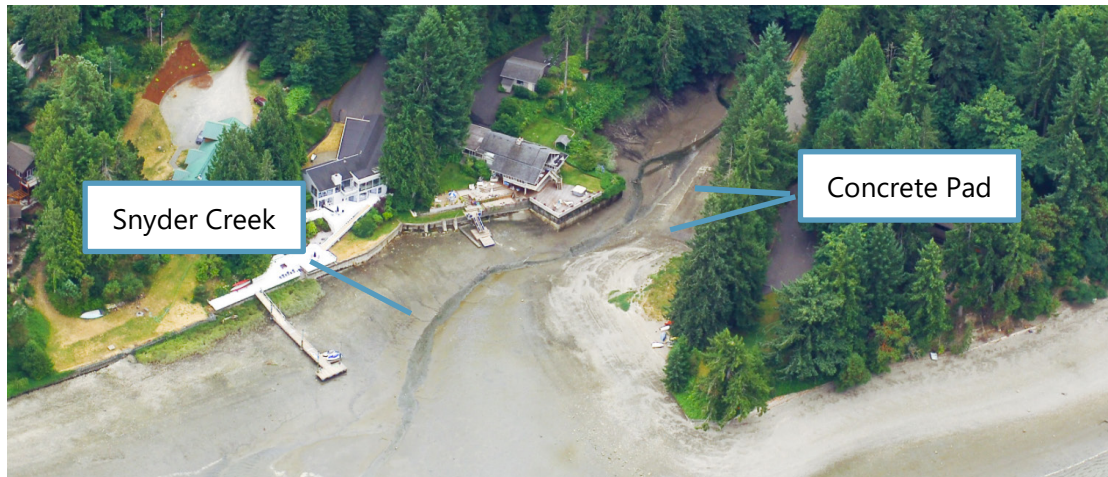
**Figure 4: Snyder Creek Channel Alignment at Mouth, 2006 (WA Dept. of Ecology, 2021)**

The number and size of creek meanders and the location of the creek channel itself is constrained by a concrete pad that armors much of the western bank of the creek (which is on the project site) and a large bulkhead on a private property along the eastern bank of the creek that protrudes out into the

creek delta (see Figures 4 and 5). Removal of the concrete pad as part of the armor removal project would widen the creek delta and allow for additional natural creek processes to be restored at the mouth. In addition, as sediment moves around the point and towards the creek delta following bulkhead removal, removal of the concrete pad will provide additional area for the creek to adjust.

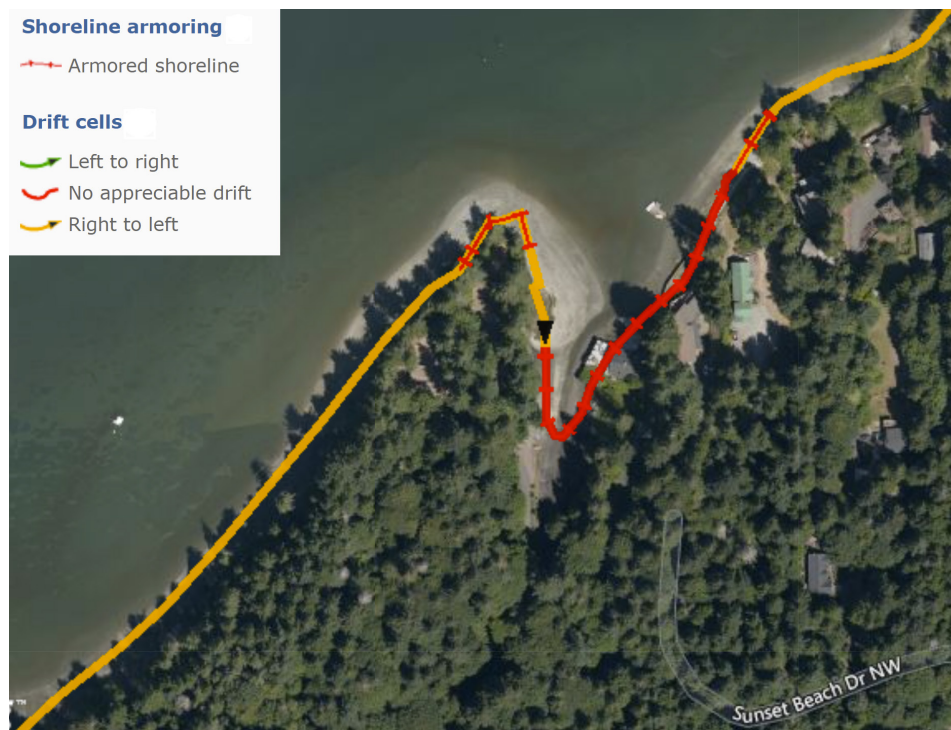
**Figure 7: Littoral Drift and Armored Shorelines at the Project Site (WA Dept. of Ecology, 2021)**

Shorelines to the east and north of Snyder Creek are mapped as armored (see Figure 7) with a variety of vertical bulkheads and rip-rap slopes. The mouth of Snyder Creek is identified as a creek delta with no appreciable transport of sediment (i.e., drift), so provides no sediment source to the project area.

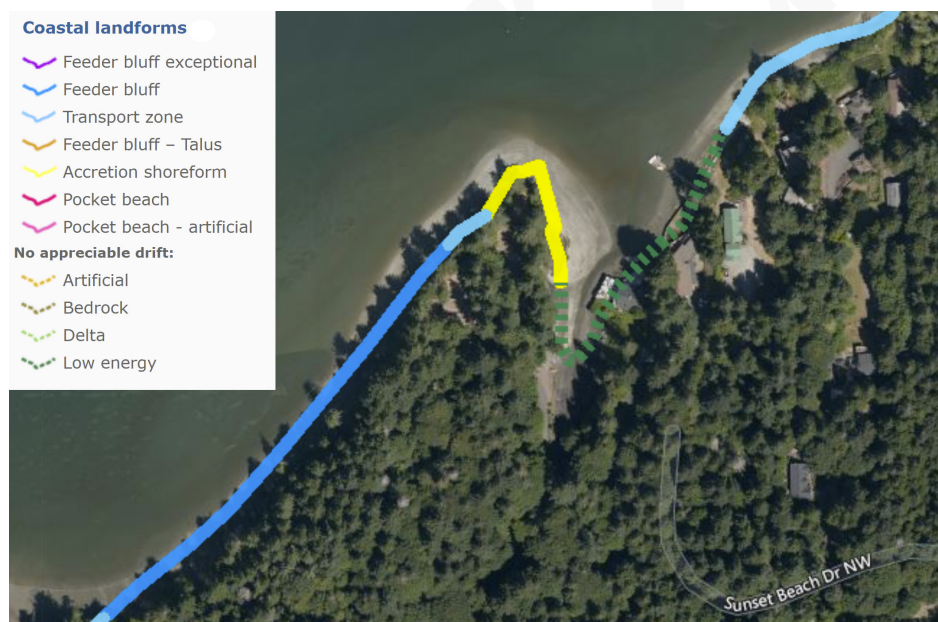
**Figure 8: Coastal Landforms (CGS 2017)**

and an accretionary shoreform<sup>3</sup> around the point (see Figure 8). This, along with the lower energy wave climate, suggests that the shoreline fronting the concrete bulkhead is relatively stable under natural processes and that if the concrete bulkhead was removed significant long-term erosion of the shoreline is not expected. There will be a period of initial adjustment after the bulkhead is removed as the site adjusts to a more natural condition following over 30 years of structural stabilization. After this period of adjustment, however, the erosion rate at the project shoreline is expected to be relatively slow. Shoreline change at the site can be observed at the eastern staircase where the northern side of the staircase is armored with the concrete bulkhead, but the southern side is unarmored. There is an obvious setback at the natural shoreline to the south of about 4 feet from armored shoreline alignment to the north. If the concrete bulkhead was constructed around 1990, this accounts for an average erosion rate of less than 0.2 feet per year. Therefore, the rate of erosion of the bluff once the bulkhead is removed is expected to be small following a period of initial adjustment of the bluff immediately following armor removal.

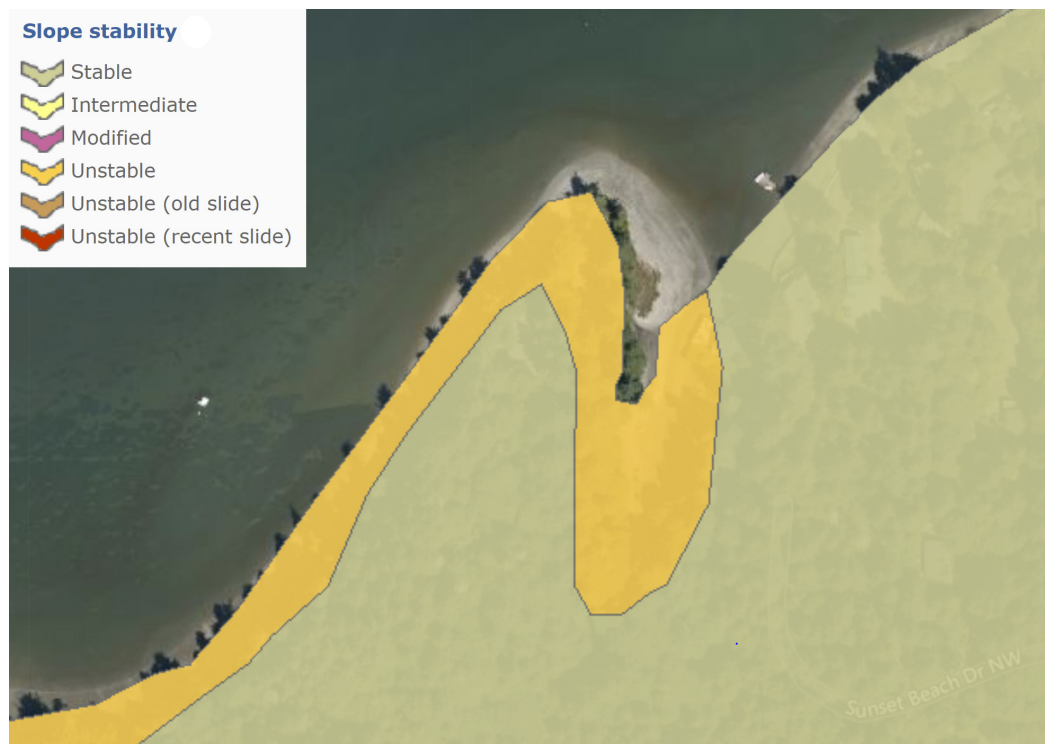
**Figure 10: Slope Stability (Washington Department of Ecology, 2021)**

Slopes along the project shoreline are mapped as unstable within approximately a 20 to 70-foot setback area from the shoreline along the entire project site (see Figure 10). The instability is due to the slopes along the shoreline being primarily sand which is easily eroded by precipitation, burrowing animals, and freezing and thawing. Slopes are mapped as stable back from the shoreline area in-line with where the geology changes from Pre-Vashon sandy to Vashon Recessional Outwash (see Figure 9). The site will be susceptible to shallow landslides within the Pre-Vashon sand deposits along the shoreline which is part of the feeder bluff shoreform characteristic. Landslides have been identified through LiDAR analysis to the south and north of the concrete bulkhead (Washington Division of Geology and Earth Resources, 2009). However, the site does not appear to be susceptible to deep seated landslides because of the presence of the Vashon Outwash landward of the sandy deposits.

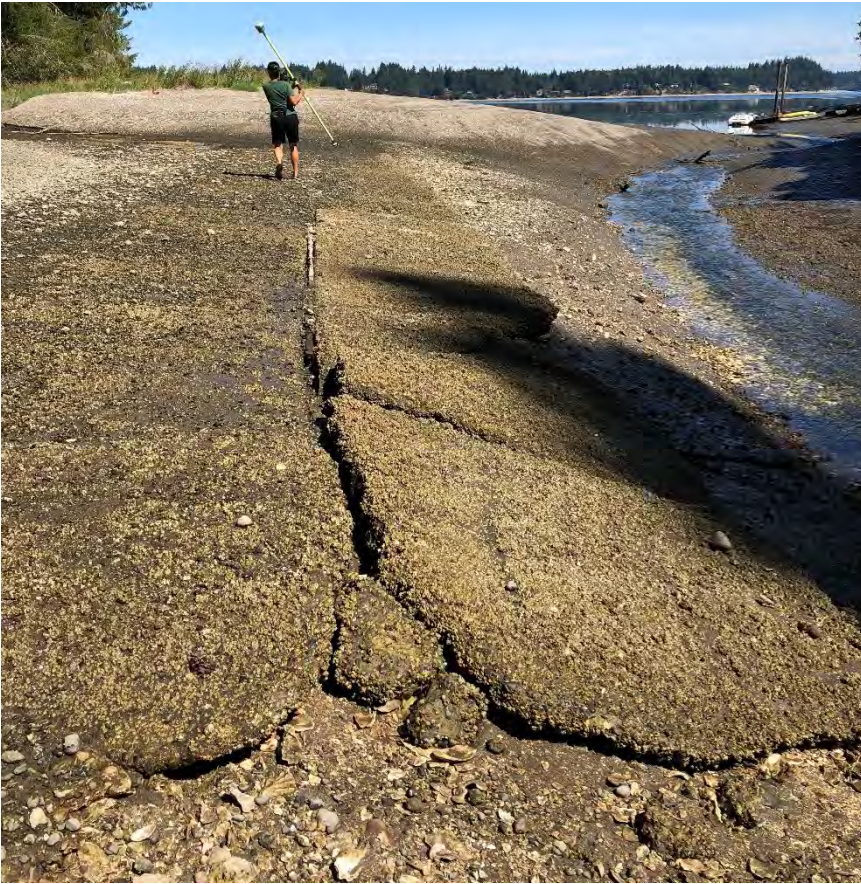
Photograph #-3. Concrete Pad Along Left Bank of Snyder Creek on Project Shoreline (looking north)

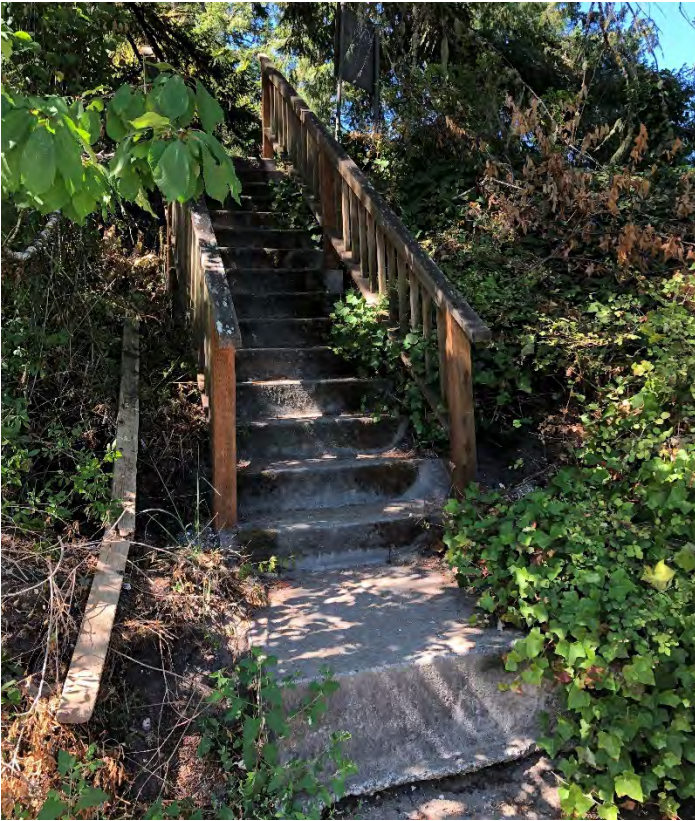
Photograph #7. Eastern Beach Access Staircase (Concrete with Wood Railing)

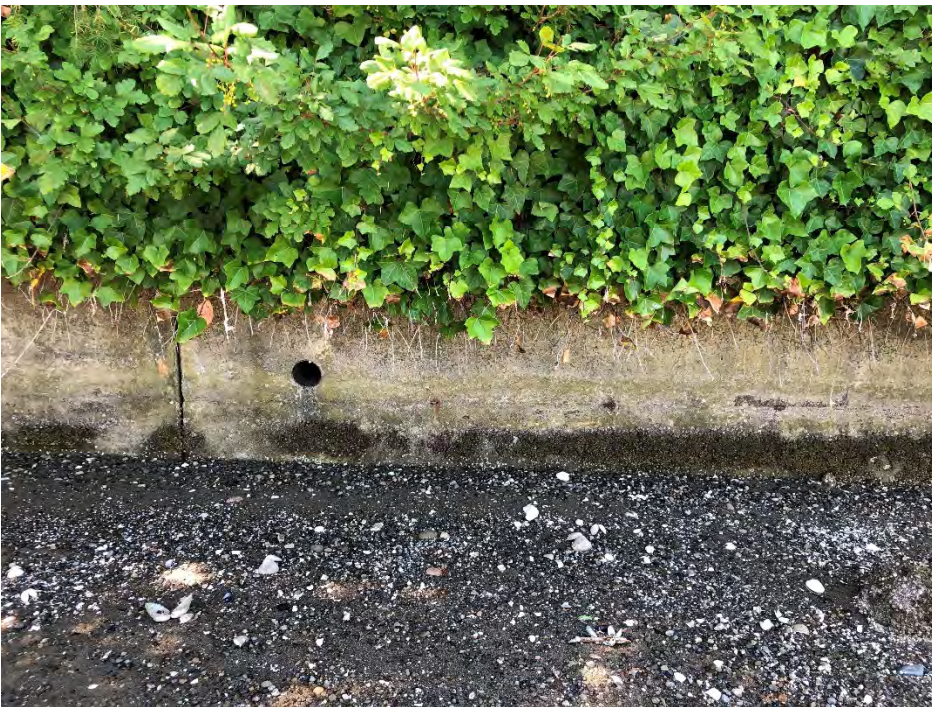
Photograph #8. Toe of Concrete Bulkhead to the West of the Eastern Access Staircase

Median sea level rise is predicted to be 0.8 feet by 2050 and up to 2.2 feet by 2100. At present, the elevation at the toe of the bulkhead varies from 12 feet to 14 feet NAVD88. Current tidal levels are summarized in Table 1 and future predicted tidal levels with sea level rise are summarized in Table 2. MHHW and HAT elevations at the site are currently 10.2 and 13.0 feet NAVD88, respectively. By 2050 these elevations are expected to increase to 11.0 and 13.8 feet NAVD88, respectively and by 2100 to 12.4 and 15.2 feet NAVD88, respectively. At present, the highest tides can reach the toe of the bluff, but MHHW is waterward of the toe of bluff. This will also be true in 2050; but by 2100 portions of the toe of the bluff are expected to be inundated at MHHW and all of the bluff toe is expected to be inundated at HAT.

If left in place, the toe of the concrete bulkhead will be impacted by wave runup and tidal inundation more often as sea levels rise. This will result in increased localized erosion at the toe of the bulkhead

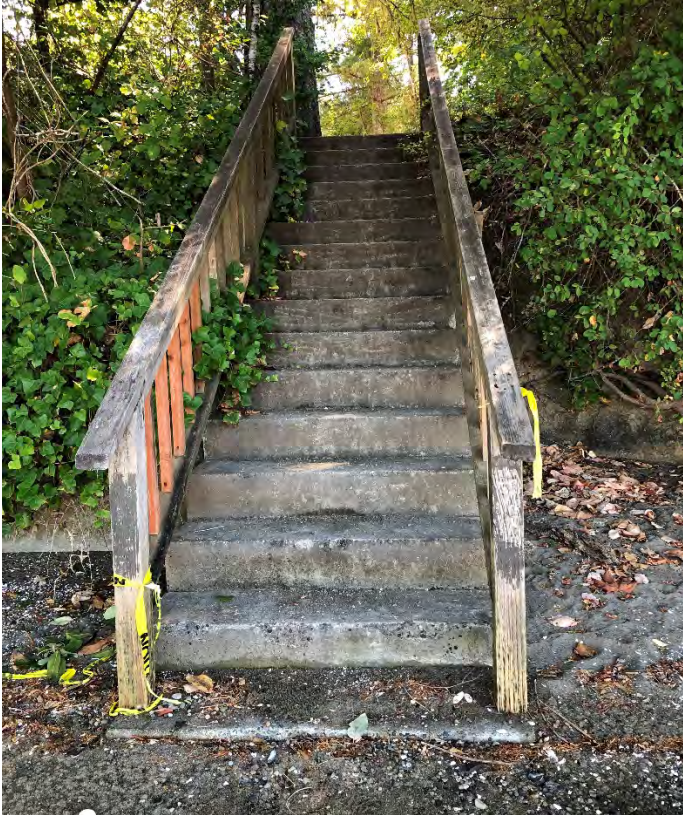
Photograph #-12. Western Beach Access Staircase (Concrete with Wood Railing), Natural Shoreline to Right

Concept #1 retains both staircases that provide access to the shoreline from the Upper Parking Lot. The western staircase is in poor condition; the wooden railings need to be replaced and the concrete stairs have some areas of spalling. In addition, the western staircase appears to be structurally connected to the concrete bulkhead, and it may not be feasible to remove the bulkhead without damaging the staircase. Concept #2 retains only the eastern staircase, which appears to be in good condition and is not connected structurally to the concrete bulkhead (from visual inspection). The eastern staircase also leads to an asphalt path from the top of the staircase to the Upper Parking Area, which is also retained in Concept #2. Concept #3 removes both staircases and the asphalt walkway and limits beach access to the access ramp/walkway currently located at the lower parking area. Signs would need to be installed at the upper parking lot directing pedestrians to the lower parking area to access the beach.
